Division of Hazardous Waste Management

March 2001

Facility Name:	Envirosafe Services of Ohio, Inc. (ESOI)
U.S. EPA I.D. :	OHD 045 243 706
Ohio Permit Num.:	03-48-0092
Location:	876 Otter Creek Road Oregon, Ohio
Fact Sheet Topic:	Deformed pipes in secondary leachate collection system of Cell M
Agency Contact:	Susan Aman (614) 644-2160

Envirosafe Services of Ohio, Inc. Cell M Landfill

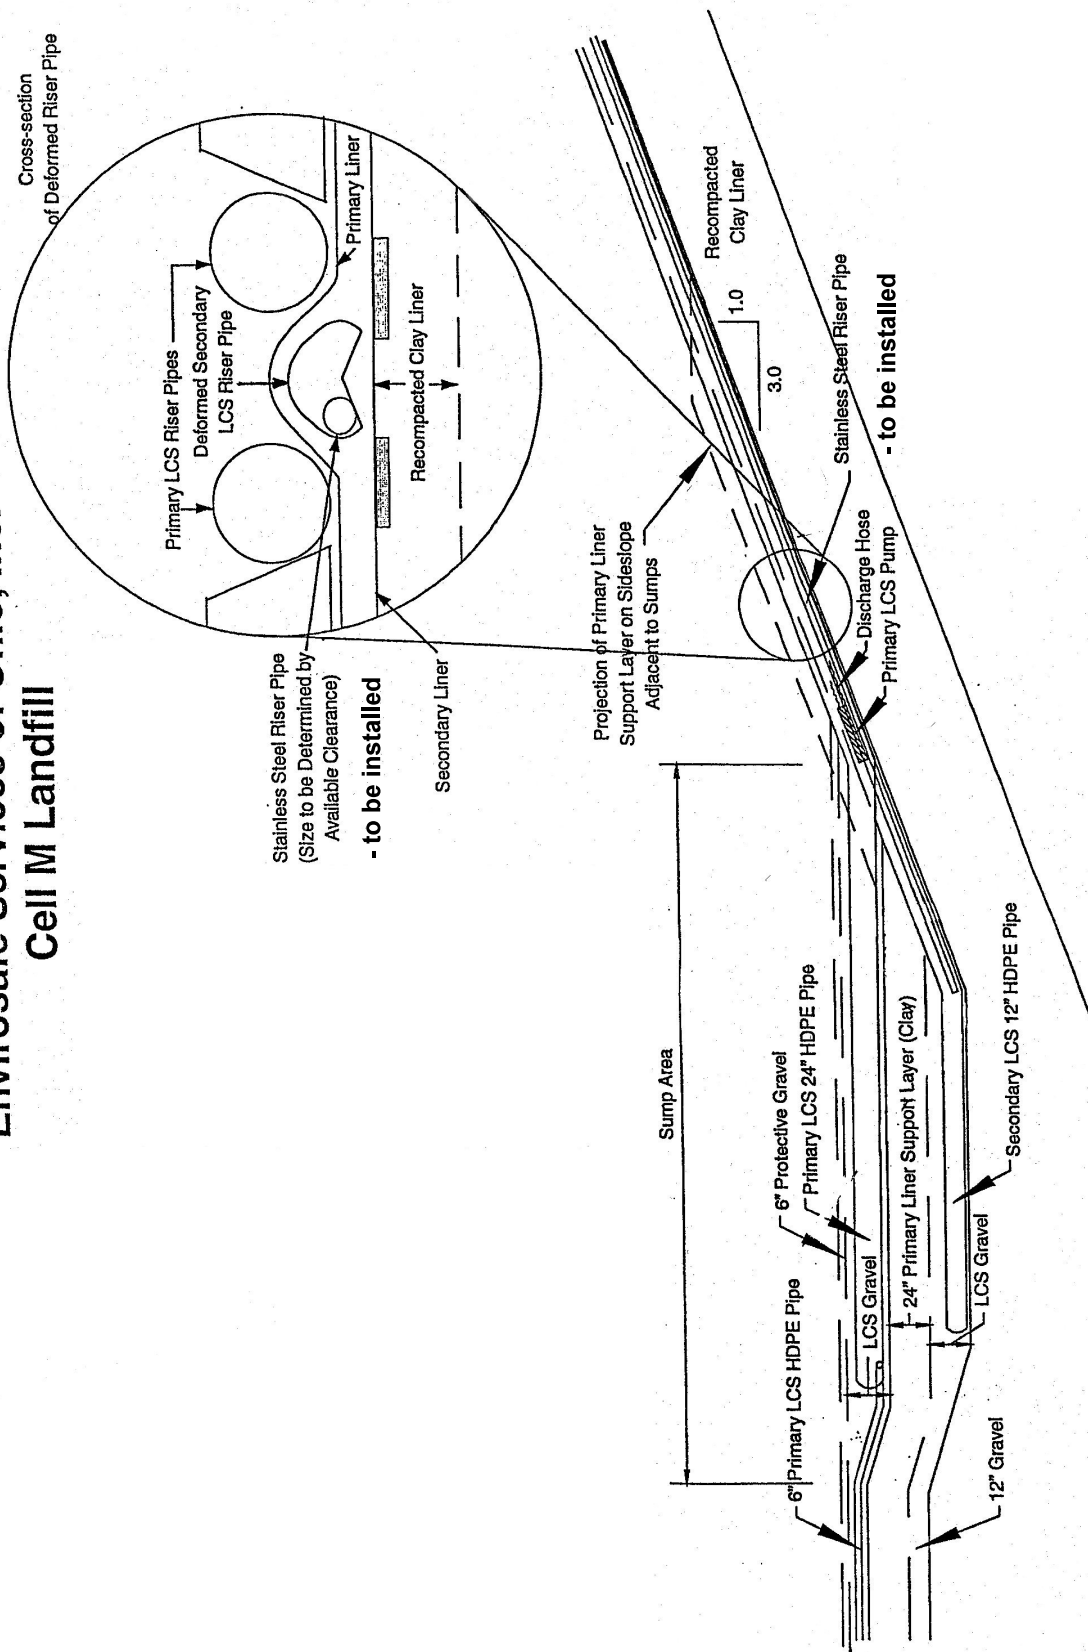
On January 8, 2001, Ohio EPA received a letter from ESOI indicating that the secondary leachate collection system (SLCS) riser pipes for sub-cells M3 and M4 had deformed. The SLCS serves as an early warning system in the event of a primary liner system failure and as a back-up to the primary leachate collection system (PLCS). The High Density Polyethylene (HDPE) SLCS riser pipes are 12 inches in diameter and run down the side slope of the cell into leachate collection sumps (see attached figure).
